# PROPERTY INSPECTION REPORT

**CG HOME INSPECTIONS**

**207 Happy Close SW**

**Date of Inspection: 9/12/2023**

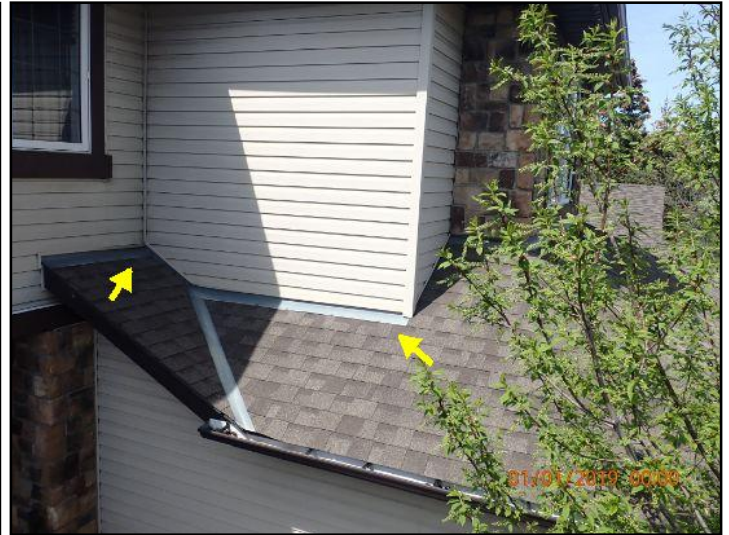
Recommend re sealing all flashing to prevent possible moisture penetration.

Flashing is fitted and appears in serviceable condition where visible.

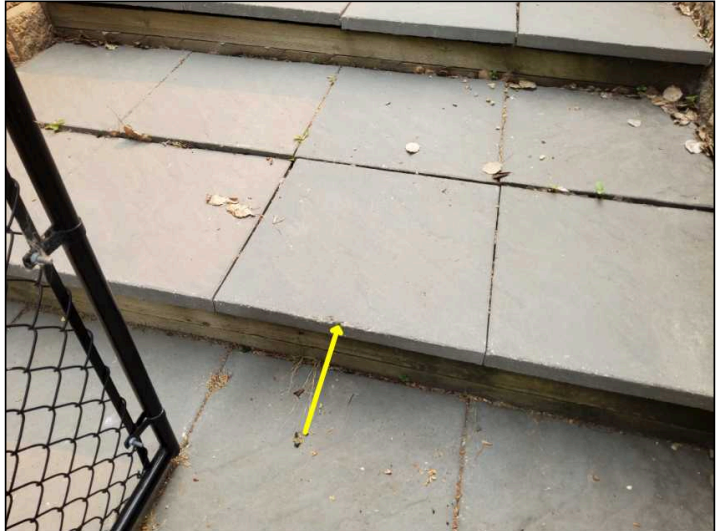
Loose paver tiles observed recommend review for repair

Loose paver tiles observed, possible trip or fall hazard, recommend review for repair

Possible trip hazard. This is a safety concern. Suggest repair/replacement as needed to ensure safety.

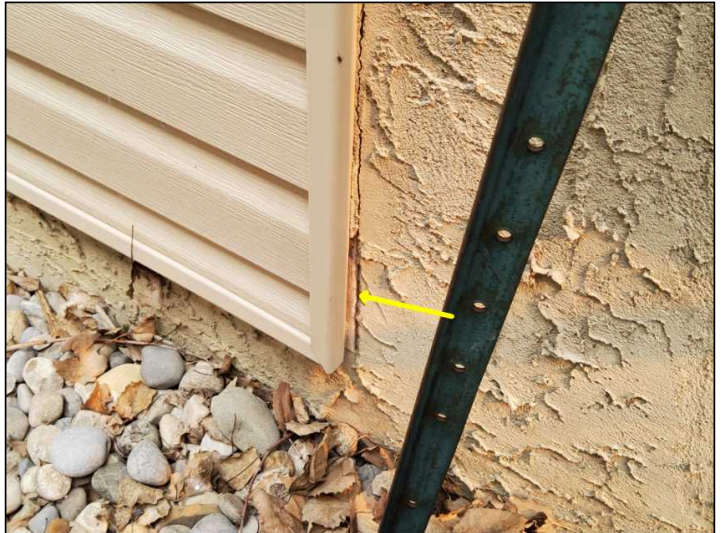
Damaged loose stone cladding observed, recommend review for repair or replacement

Suggest sealing/caulking as part of routine maintenance.

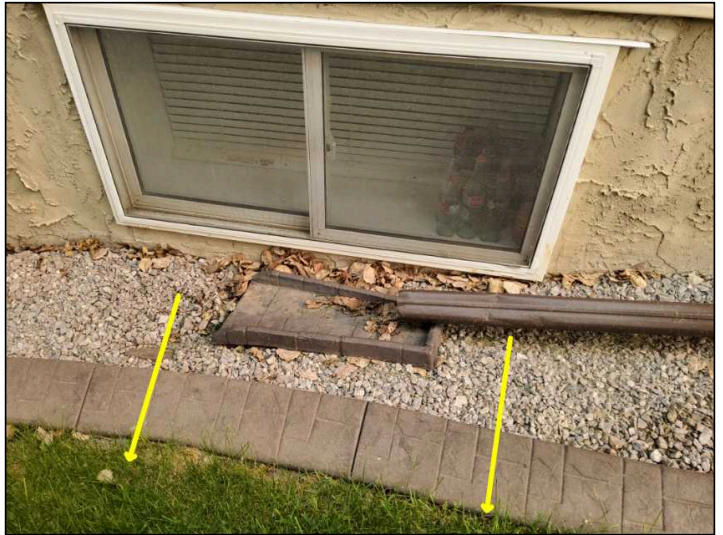
Missing and Split caulking noted maintain a good seal around all windows and doors to prevent water damage

Window is at/or below grade level - recommend grading away from window or adding a window well to reduce the risk of potential water entry.

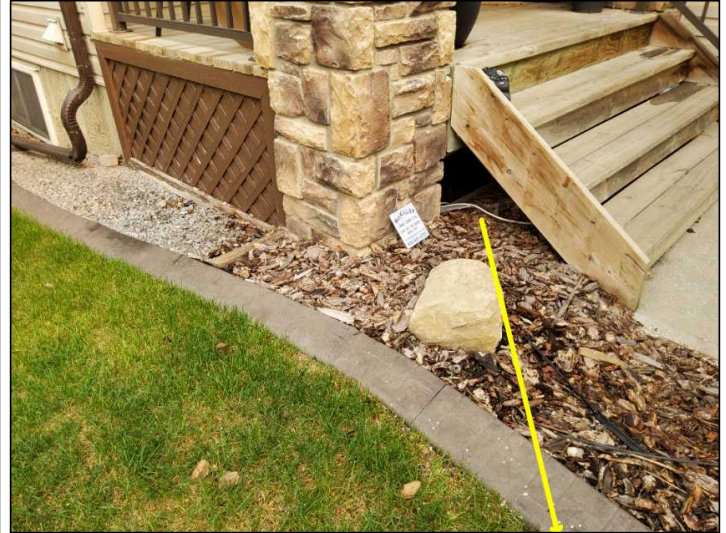
Porch is weathered, suggest cleaning, as necessary, and treating with an oil based, water-repellent preservative to protect and extend the life of the wood.

Recommend sealing gap at porch base to prevent any possible moisture intrusion and pest entry and grading away from structure.

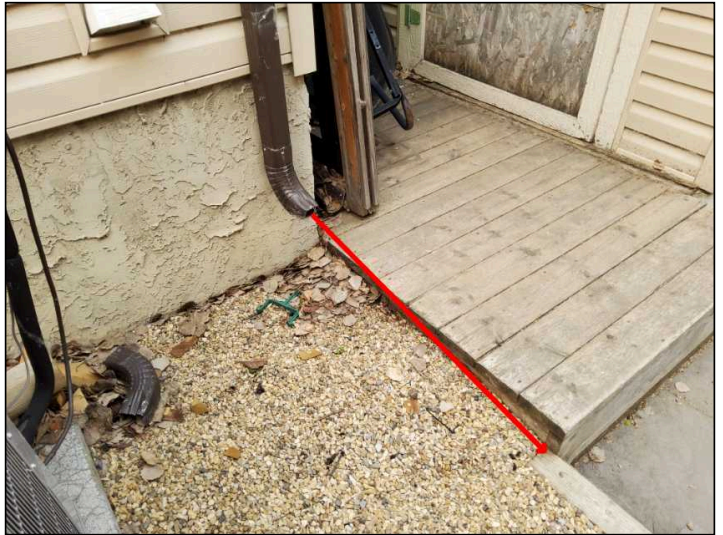
Extend downspouts 5-6 feet from the foundation of the home for effective water flow.

Add missing extension pipe to keep water away from the foundation wall

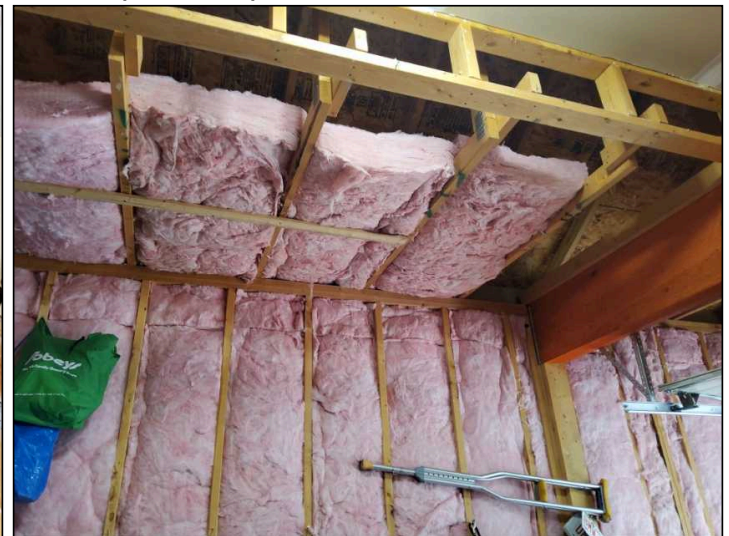
Efflorescence observed; this is a mineral deposit left behind from exterior water infiltration and vehicle snow melt off.

Garage partially insulated, loose insulation noted, Missing vapour barrier observed, recommend review for repair or replacement

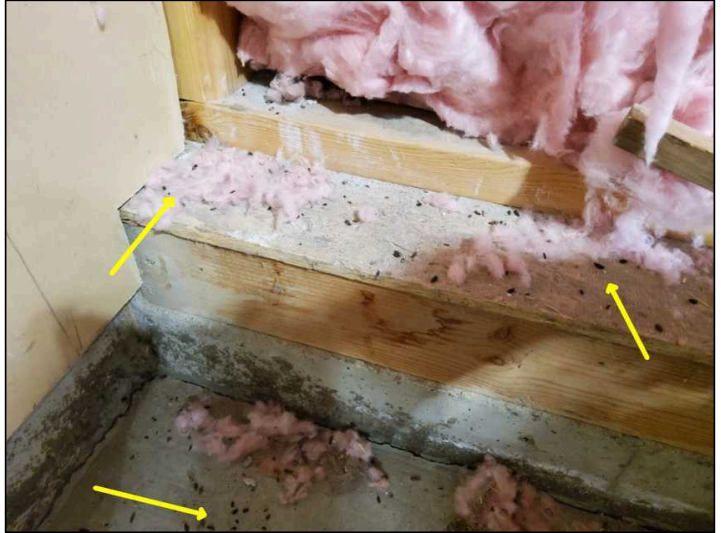
Indication of possible pest activity observed, recommend further review by a certified pest control if concerned

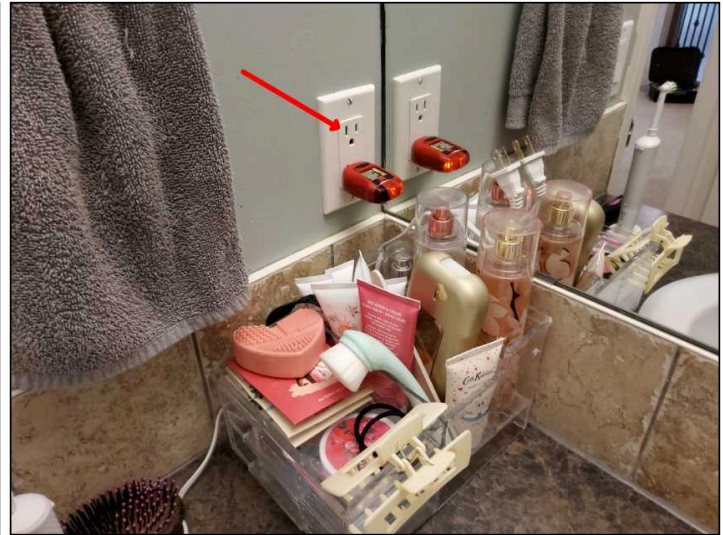
Main bathroom receptacle did not trip en suite GFCI, recommend review by a certified electrician

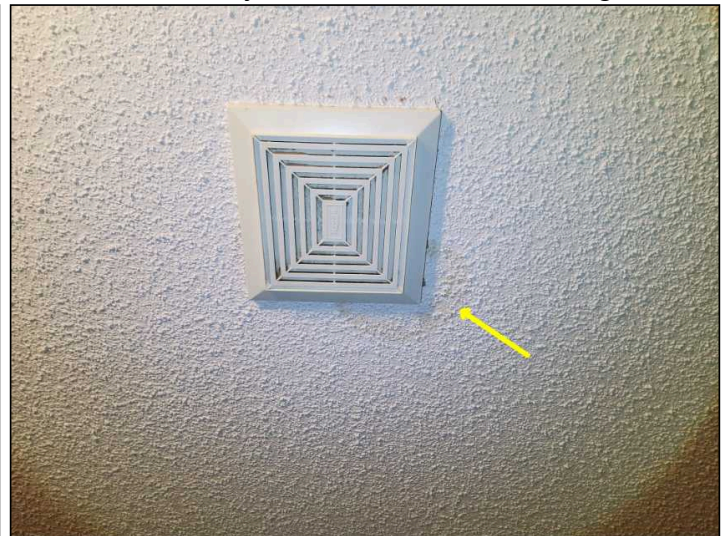
Fans are dirty and requires cleaning

Main Bathroom - Minor staining noted around the vent fan - Water stains on the ceiling around your bath fan may indicate a leak coming from the vent cap on your roof, but condensation is the more likely culprit. If bath fan ducting is not properly insulated or there is not a loop in the line, the moist air from your house will condense inside the duct, and may run back onto the ceiling.

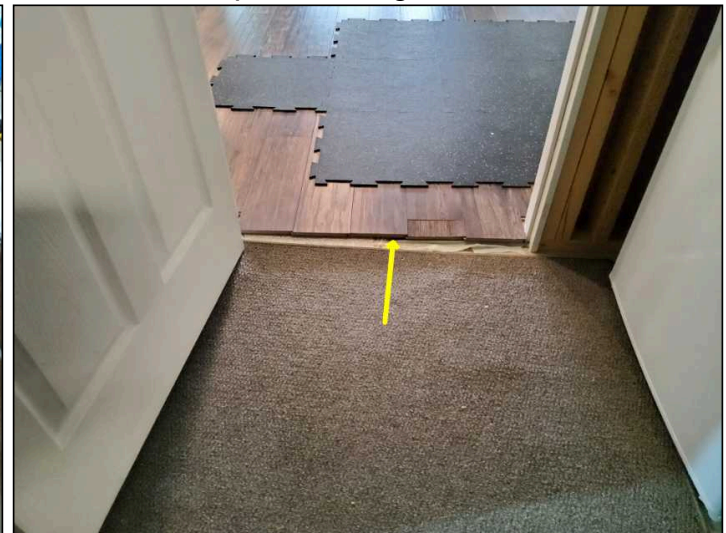
Settlement cracking noted at slab. Recommend consultation with qualified contractor should condition worsen or water intrusion occur. Recommend monitoring.

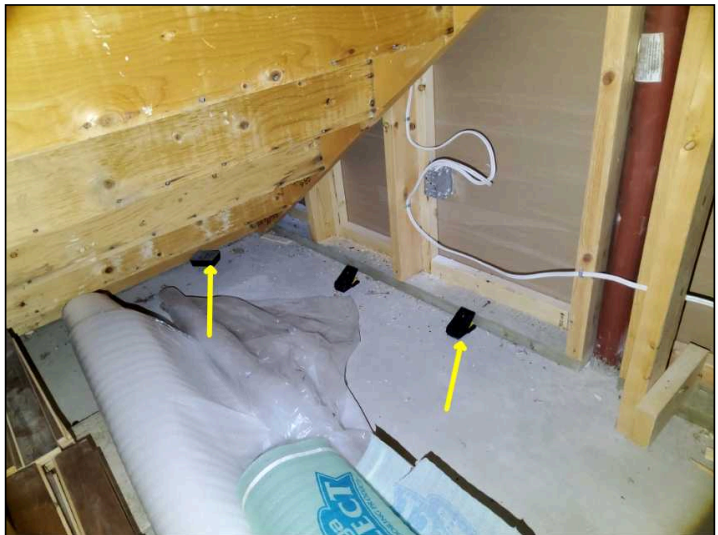
Indication of possible pest activity observed, recommend further review by a certified pest control if concerned

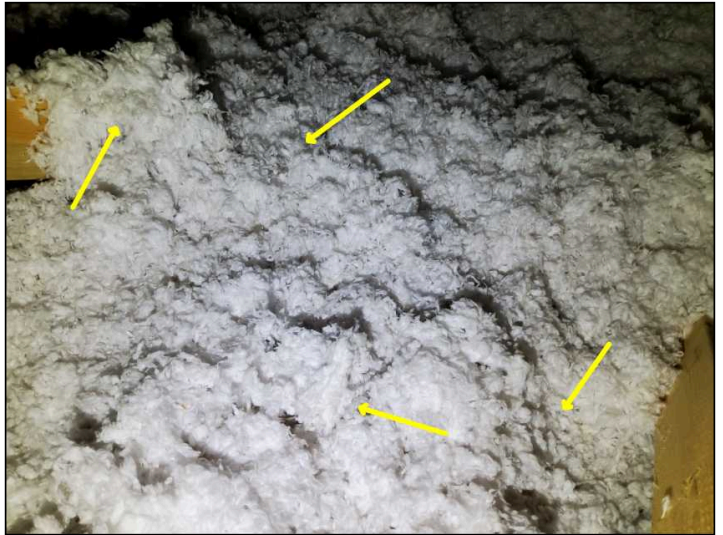
Approx 8-10 Inches of insulation noted in the attic space - Low compared to todays standards, suggest adding more to reduce heat loss.

Staining and flattening observed at insulation, this can be from attic rain conditions. Recommend further investigation into attic rain, to prevent these conditions. Recommend monitoring and ongoing maintenance.

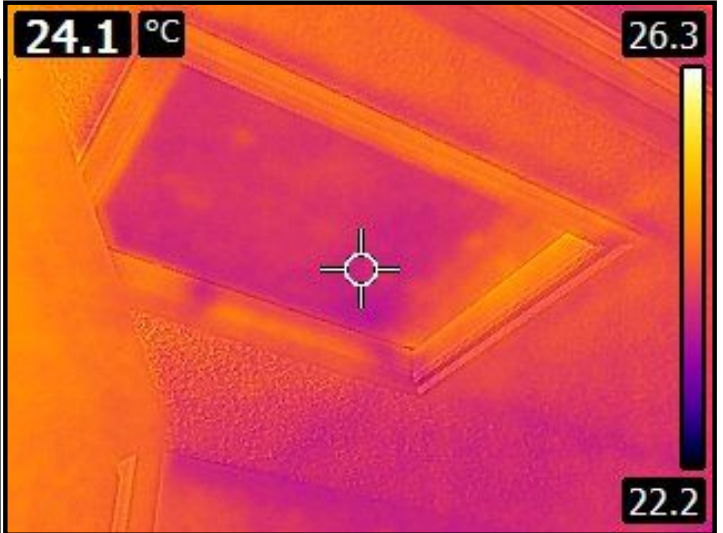
Staining and flatting observed at insulation, this can be from attic rain conditions. Recommend further investigation into attic rain, to prevent these conditions. Recommend monitoring and ongoing maintenance.

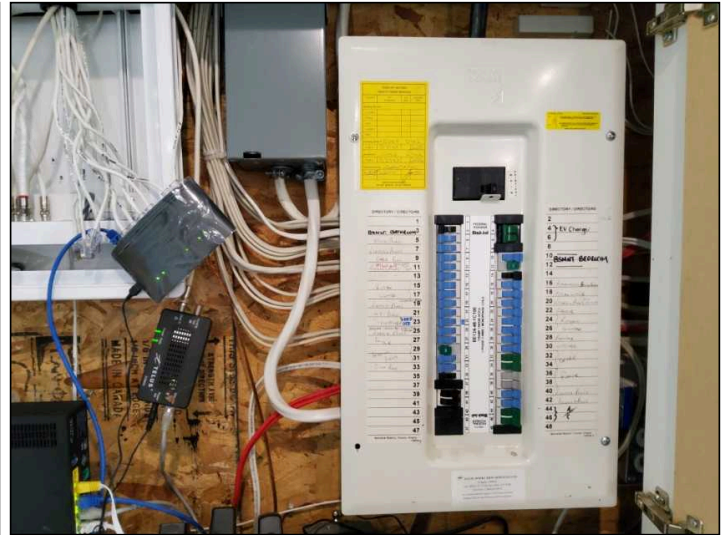
Multiple open grounded receptacles observed. Recommend further assessment by a certified electrician.

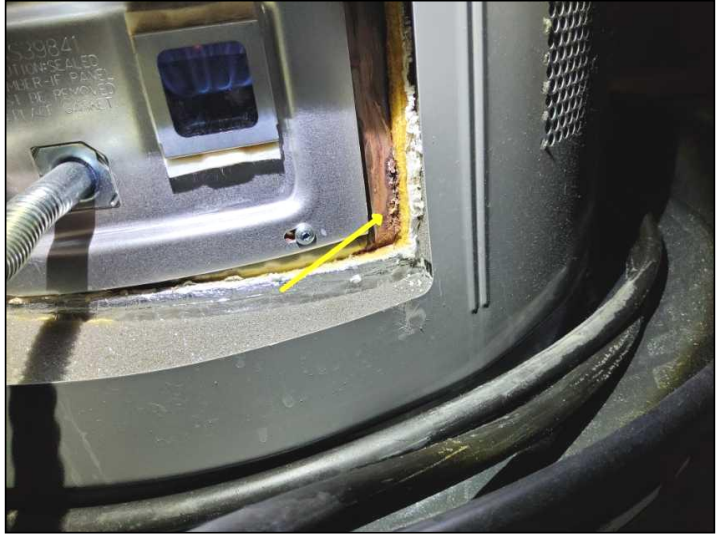
Rust and scale noted to combustion chamber

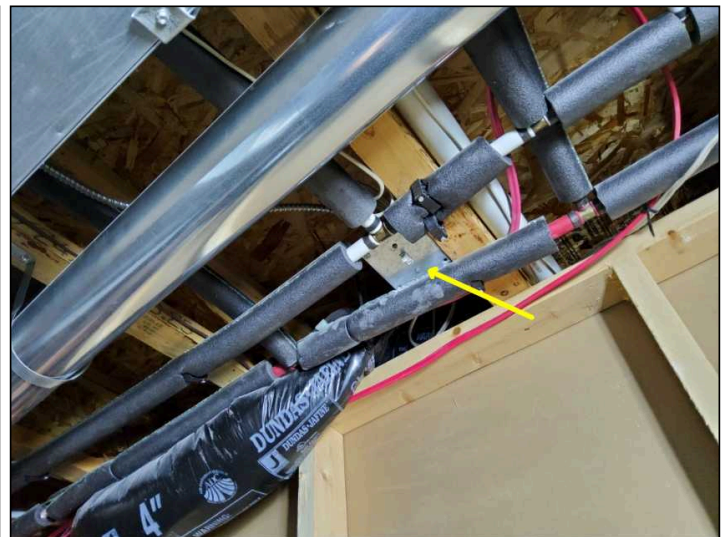
Kill switch shown to furnace - recommend relocating for easier access.

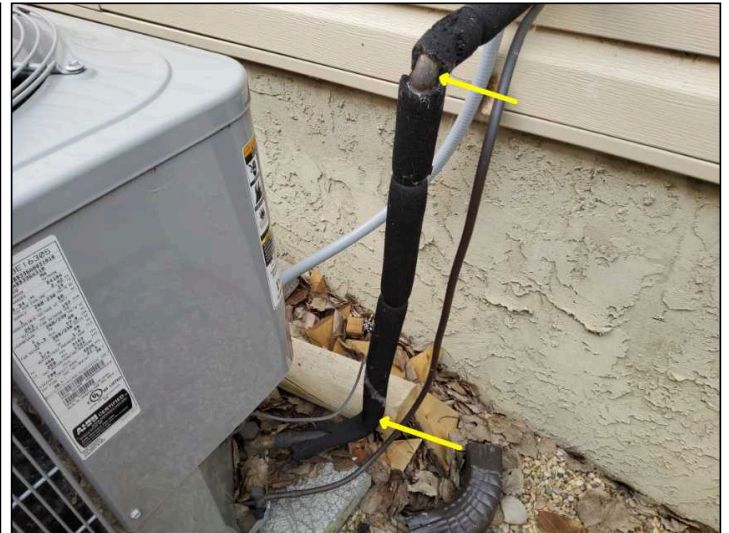
Deterioration noted to the insulation at the condensate line. Recommend replacement.
